# Survey Report

Arden House 210 Findhorn FORRES IV36 3YU

Report prepared for Mrs Lorna Ross

25 January 2023

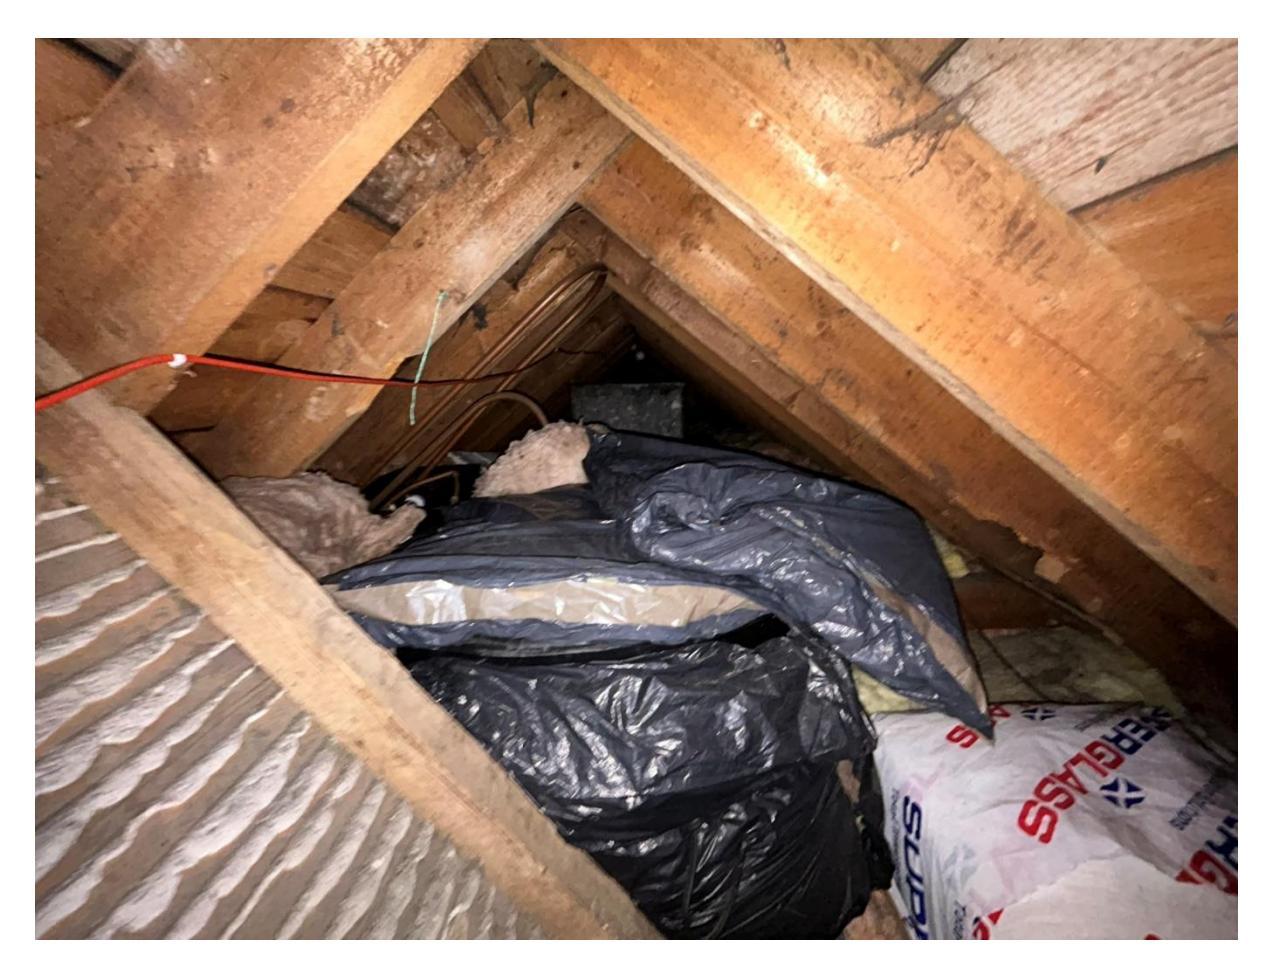
Where seen, the timbers were sound and dry with no obvious signs of any decay.

Our inspection revealed evidence of infestation by the common furniture beetle (Anobium punctatum). Around 75% of all woodworm damage is caused by this wood boring insect, with both softwoods and hardwoods being vulnerable to attack.

Old and apparently inactive infestations were evident to the accessible and exposed timbers. Treatments appear to have been carried out in the past and the client should therefore check for the availability and validity of any guarantees.

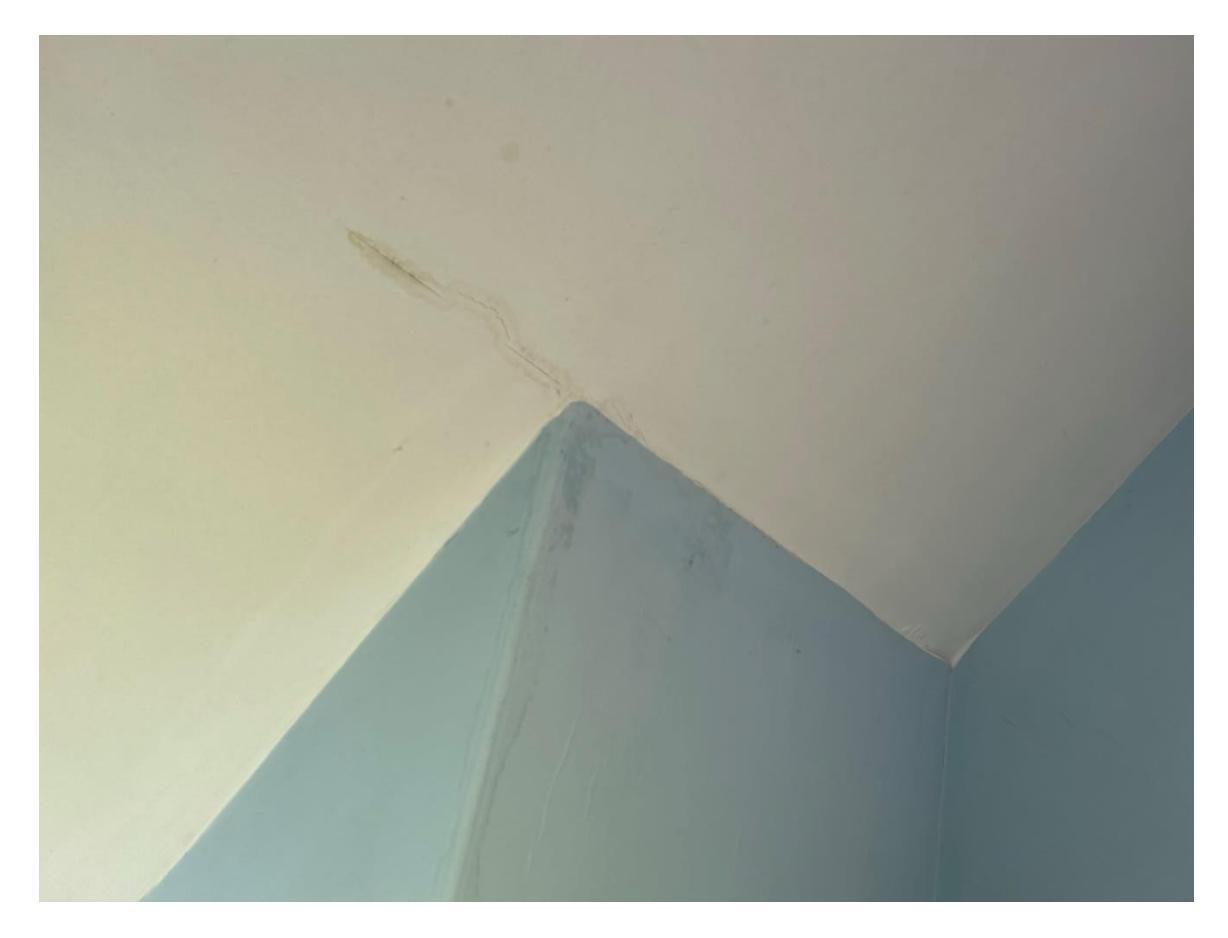
Previous water penetration

Cracked plaster was evident on walls and ceilings but this appears to be historic.

These walls and ceilings could be left until such times as when decoration next occurs, and any remedial works could then be carried out.

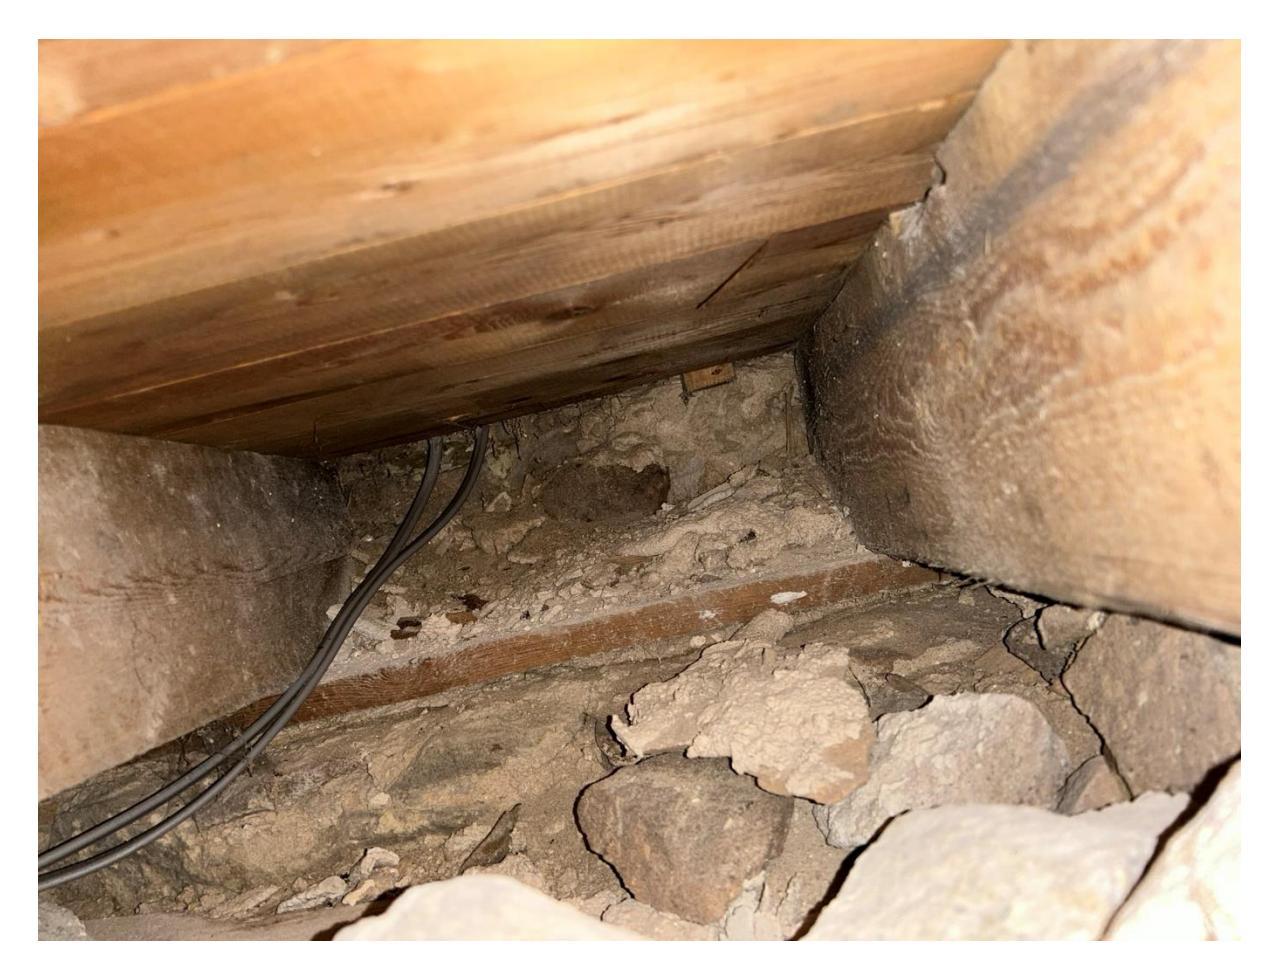
The solum was found to be bare earth/sand which is very common for Findhorn. This was found to be very dry with no sign of dampness to this area.

The wall plates were covered with debris and ideally could be cleared at some point in the future.

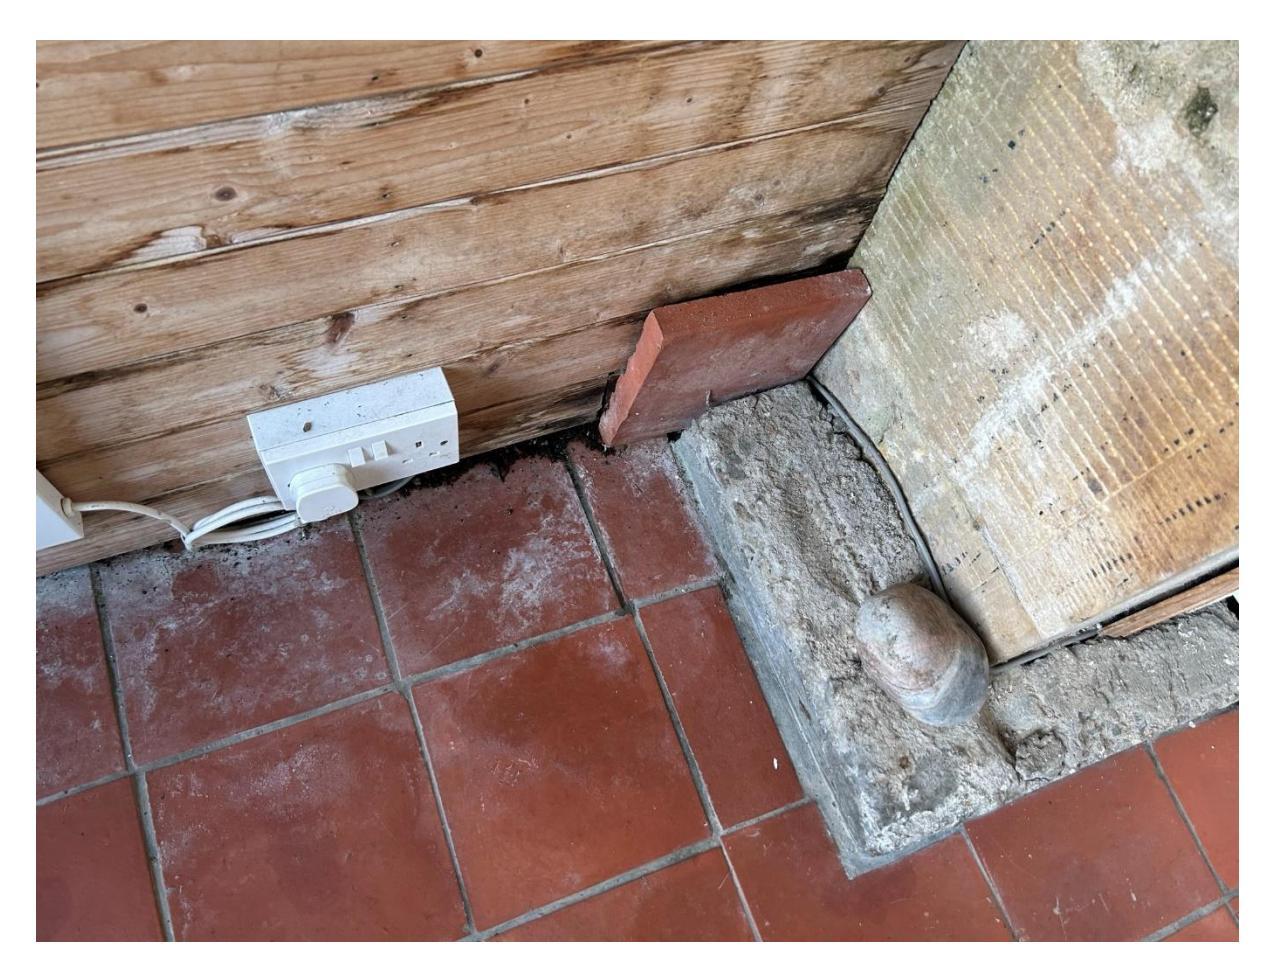
An area of dampness was noted to the lower levels, and this could be due to the type of construction. I would imagine some remedial repairs could be carried out by a local joiner to lower wall plates.

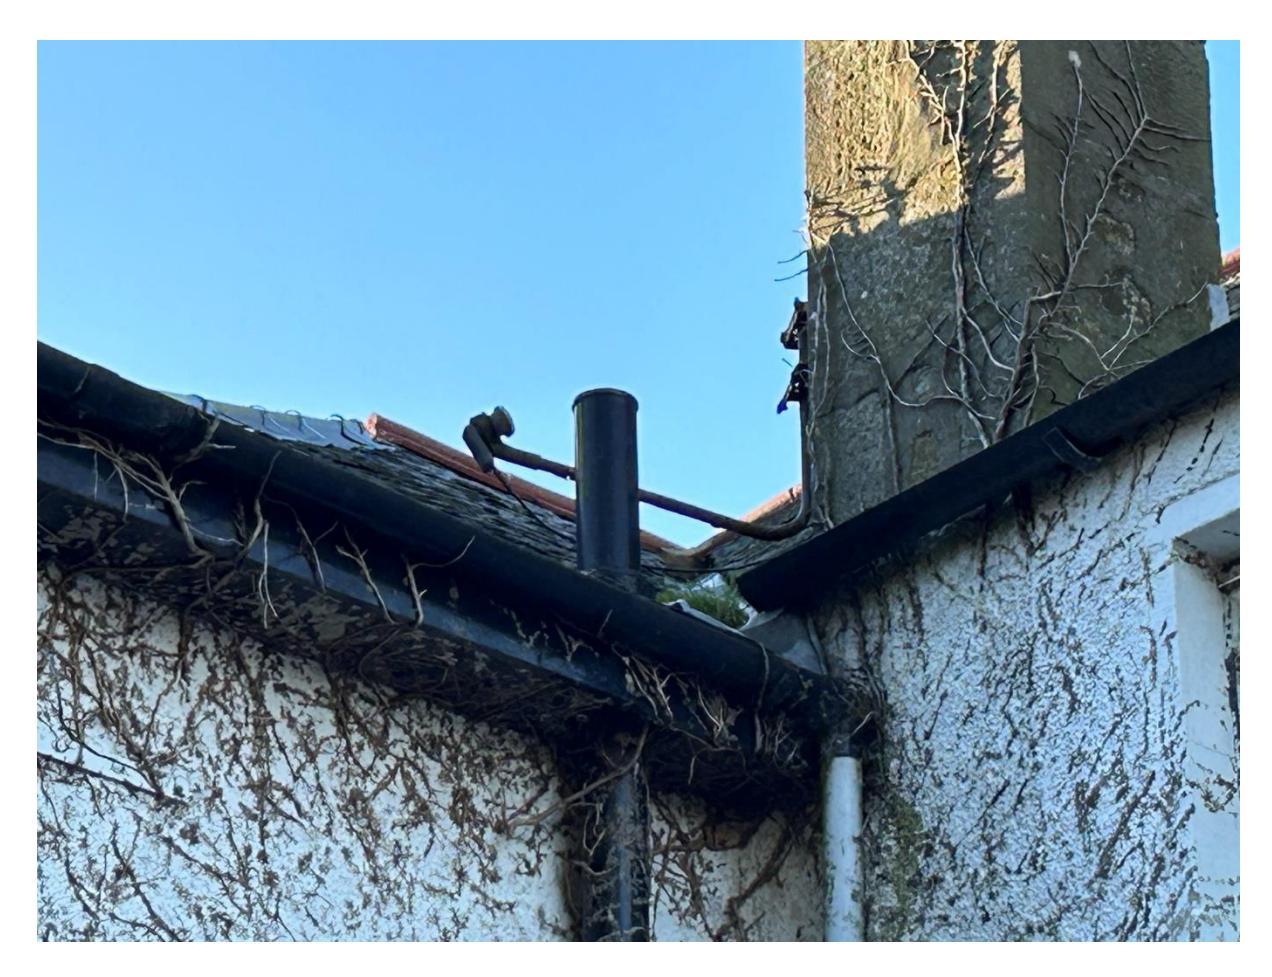
The ridge appeared to be original clay sections and lead cover pieces. Where seen, only pointing works are required on the clay pieces and perhaps the lead fixings renailed.

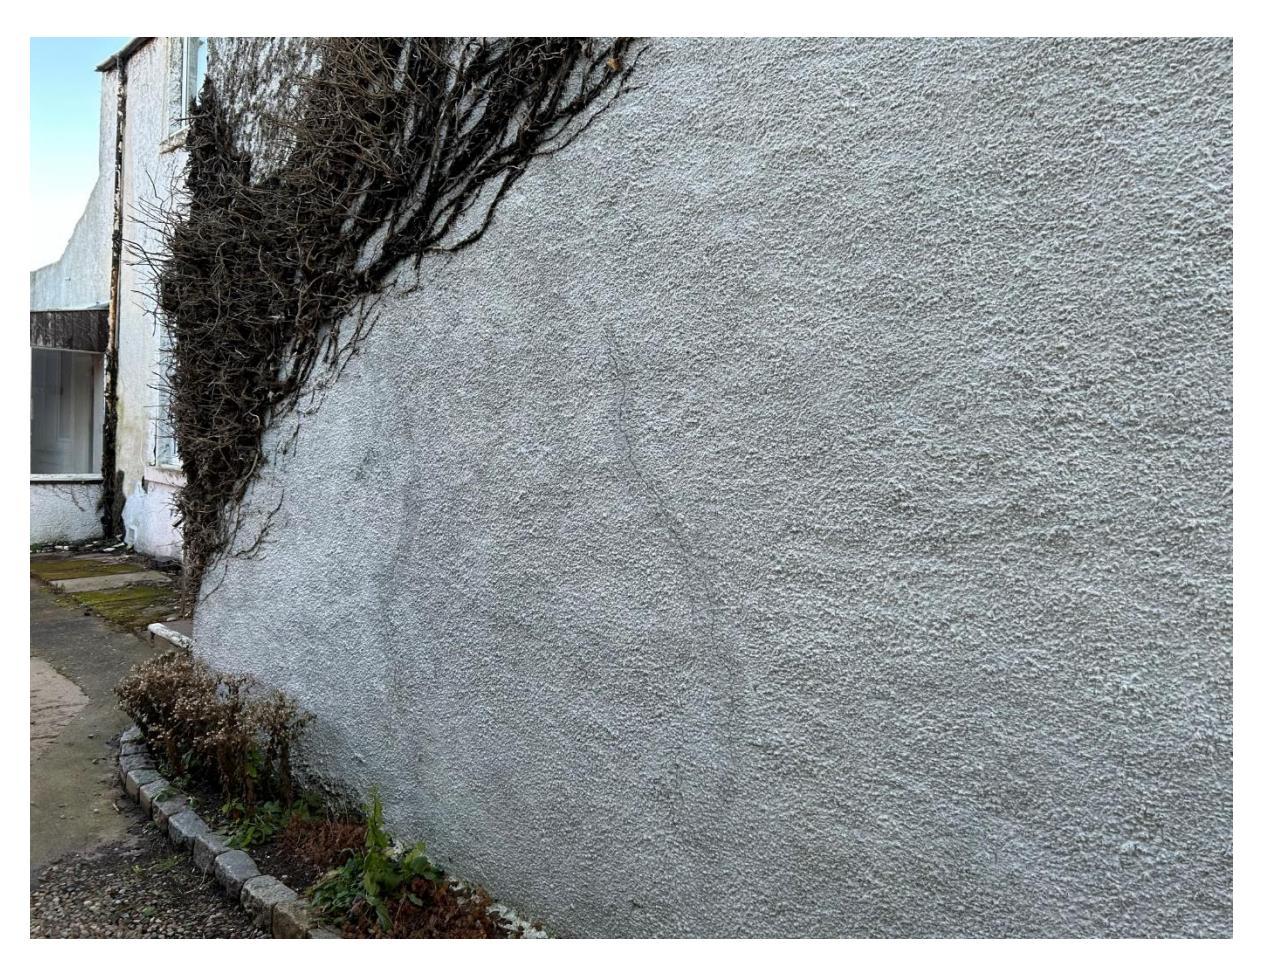
All walls have been coated with a cement render which if the original sub-structure were blockwork would be fine but not if the structure is sandstone. The chimney stacks are sandstone so we would assume the property has been built the traditional way, with sandstone and lime mortar.

The walls appear to have a few cracks on the render on various locations but this would be expected if coated onto the sandstone as the cement is not flexible enough.

Ideally, at some point in the future, the original sections of the building requires to have the cement removed and repointed or recoated with a breathable render or coating. This would help the old building start to 'breathe' again.

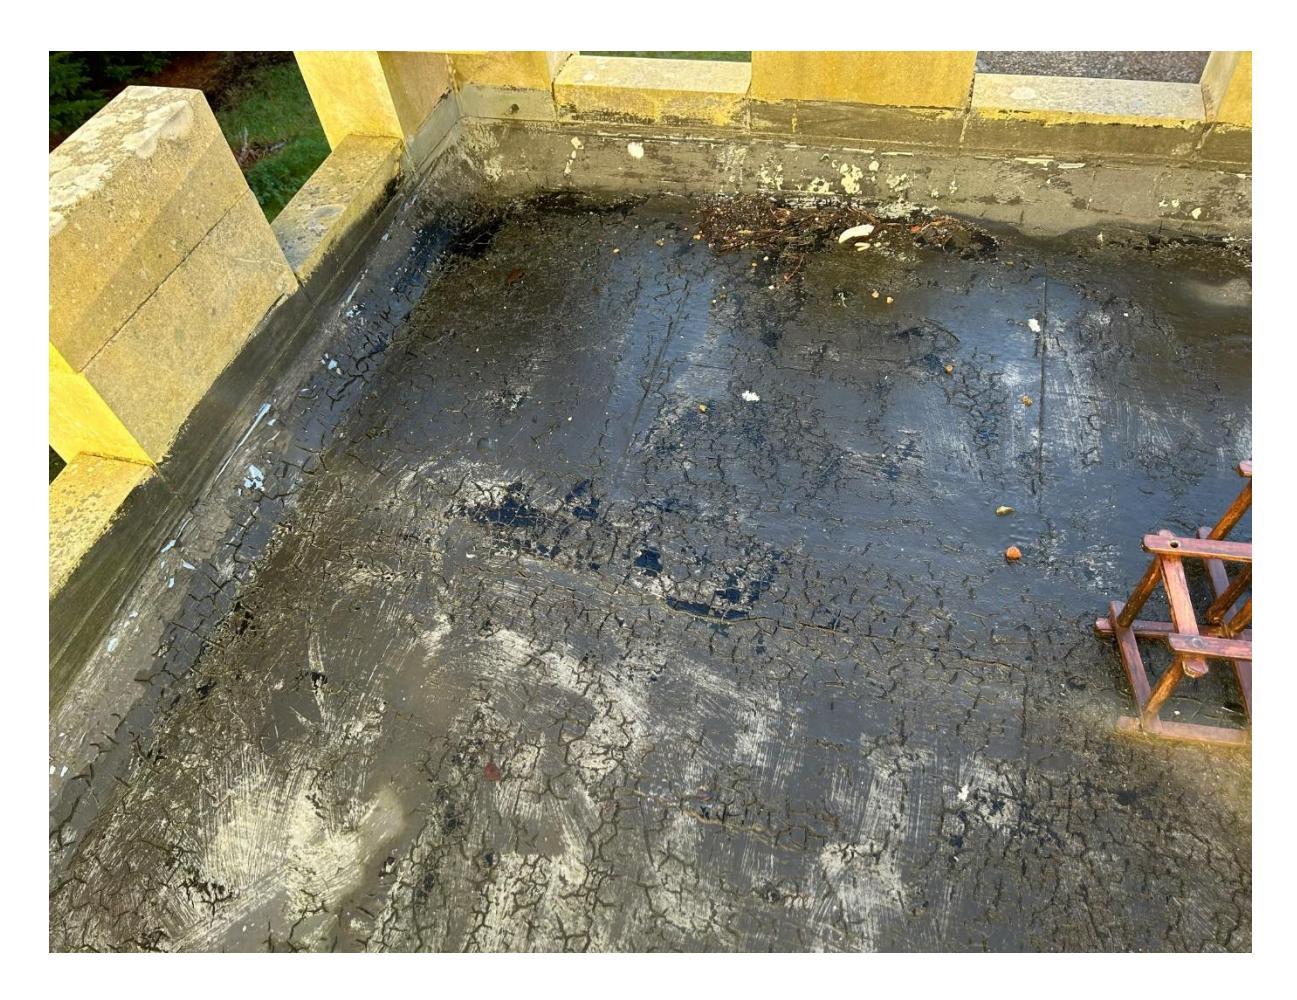
The flat roof has some form of bitumen coating on the surface. This is now cracked and breaking up. There is no way of knowing the original covering until this is removed and a new coating applied.

When the property was built, lead would have been used.

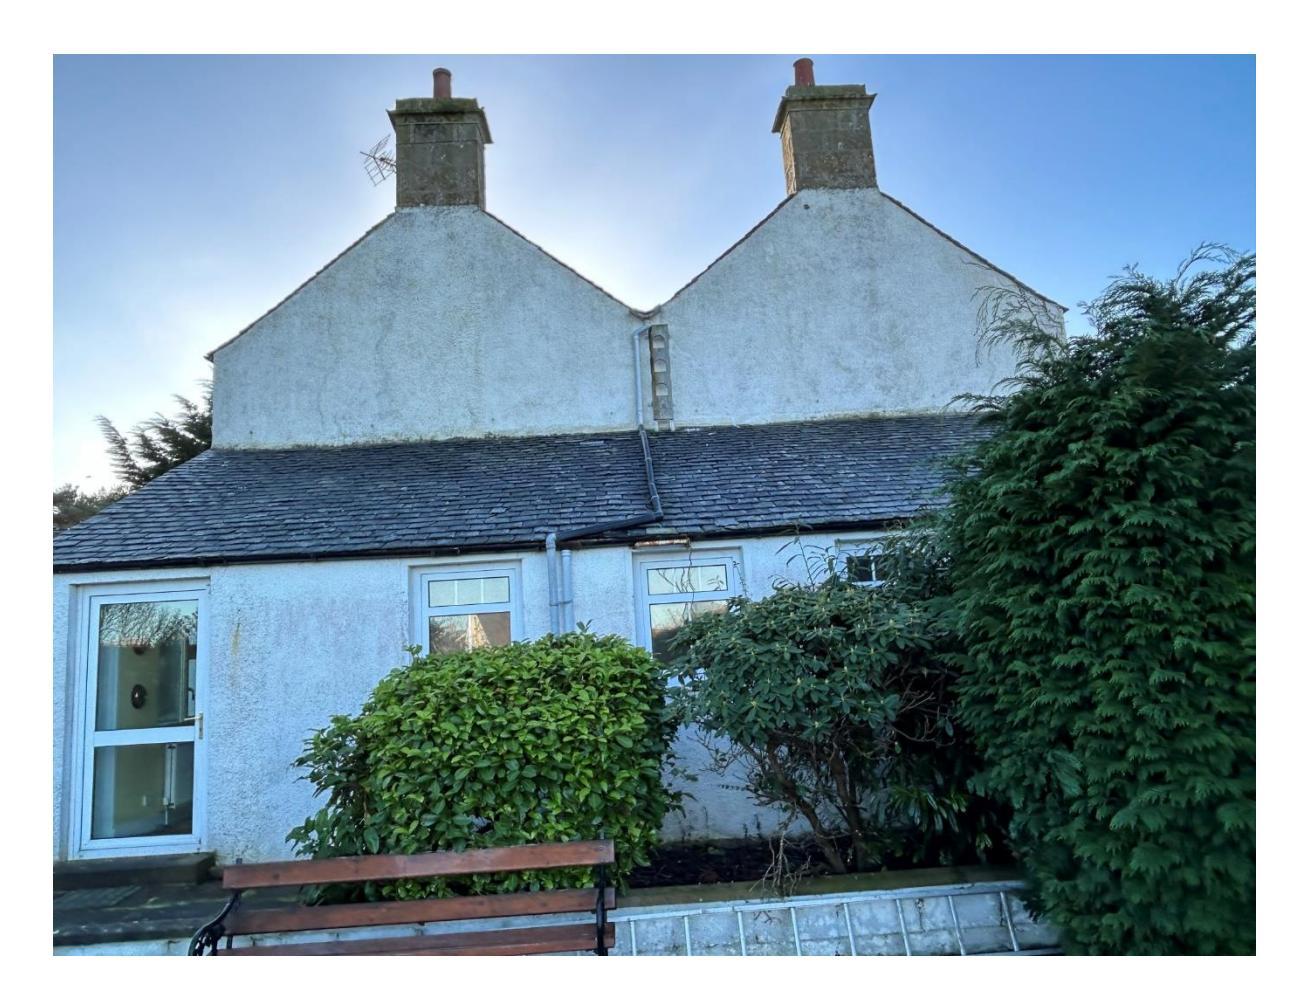
Cannot be seen from ground level.
