# Home Report

22 St. Aethans Drive,
Burghead,
Elgin,
IV30 5GP

# Single Survey

| **Date of Inspection** | 12th November 2026 |

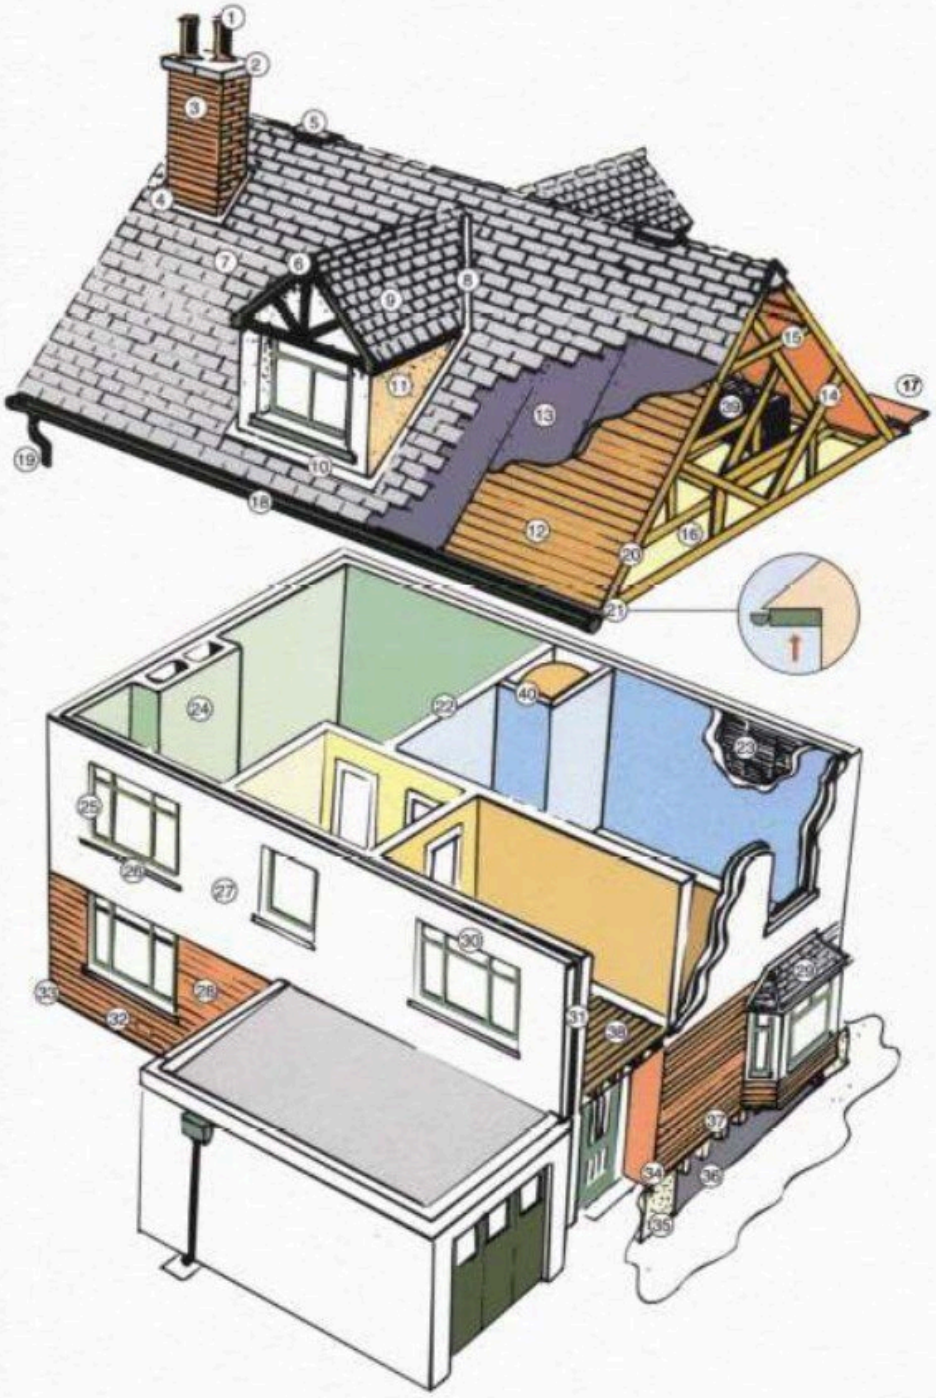
| | There is a single integral garage. |
