## **HOME REPORT**

10 SEAFORTH PLACE FINDHORN FORRES IV36 3YP

# SINGLE SURVEY

## survey report on:

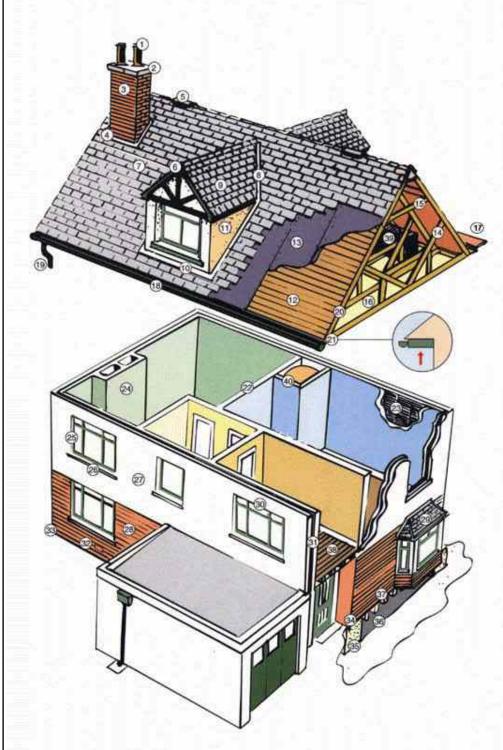
#### Sectional Diagram showing elements of a typical house

Reference may be made in this report to some or all of the above component parts of the property. This diagram may assist you in locating and understanding these items.

- 1 Chimney pots
- 2 Coping stone
- 3) Chimney head
- 4) Flashing
- 5 Ridge ventilation
- 6) Ridge board
- 7) Slates / tiles
- 8 Valley guttering
- 9 Dormer projection
- 10 Dormer flashing
- 11) Dormer cheeks
- (12) Sarking
- (13) Roof felt
- (14) Trusses
- 15) Collar
- (16) Insulation
- 7) Parapet gutter
- (18) Eaves guttering
- 19) Rainwater downpipe
- Verge boards /skews
- 21) Soffit boards
- 22) Partition wall
- 23) Lath / plaster
- 24) Chimney breast
- $\simeq$  .
- 25) Window pointing
- 26) Window sills
- (27) Rendering
- 28) Brickwork / pointing
- 29) Bay window projection
- (30) Lintels
- (31) Cavity walls / wall ties
- 32) Subfloor ventilator
- 33) Damp proof course
- 34) Base course
- 35) Foundations
- 36) Solum
- 37) Floor joists
- 38) Floorboards
- Water tank
- 40) Hot water tank
