Eden Lodge,
Dallas,
Forres,
Morayshire,
IV36 2RW

Home Report

Single Survey

Property Address	Eden Lodge, Dallas, Forres, Morayshire, IV36 2RW
Reference	1023662
Customer Name	Jordan Bowler
Date of Inspection	21st April 2025
Surveyor's name, qualifications and office	Michael McDonald BLE, MRICS DM Hall LLP Chartered Surveyors 27 High Street Elgin IV30 1EE Tel: 01343 548501 email: elginresidential@dmhall.co.uk
Prepared By	DM Hall LLP

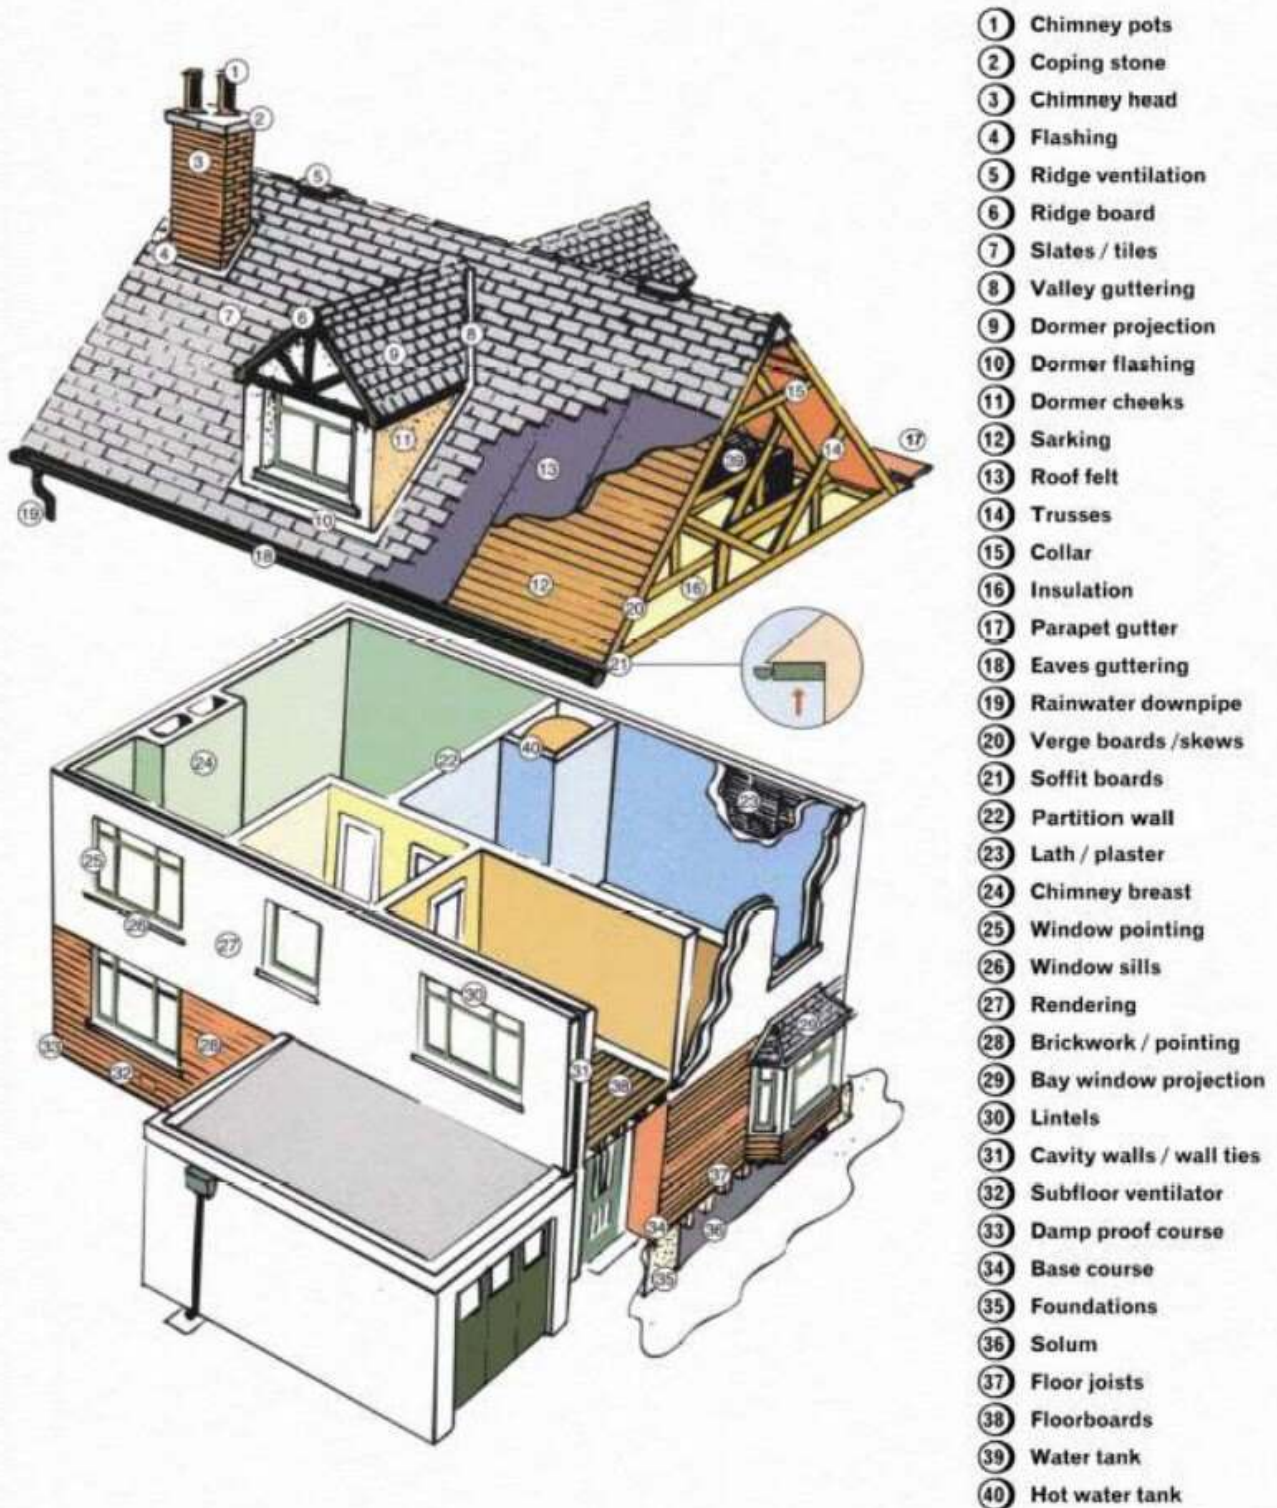
Sectional Diagram showing elements of a typical house

- ① Chimney pots
- ② Coping stone
- ③ Chimney head
- ④ Flashing
- ⑤ Ridge ventilation
- ⑥ Ridge board
- ⑦ Slates / tiles
- ⑧ Valley guttering
- ⑨ Dormer projection
- ⑩ Dormer flashing
- ⑪ Dormer cheeks
- ⑫ Sarking
- ⑬ Roof felt
- ⑭ Trusses
- ⑮ Collar
- ⑯ Insulation
- ⑰ Parapet gutter
- ⑱ Eaves guttering
- ⑲ Rainwater downpipe
- ⑳ Verge boards /skews
- ㉑ Soffit boards
- ㉒ Partition wall
- ㉓ Lath / plaster
- ㉔ Chimney breast
- ㉕ Window pointing
- ㉖ Window sills
- ㉗ Rendering
- ㉘ Brickwork / pointing
- ㉙ Bay window projection
- ㉚ Lintels
- ㉛ Cavity walls / wall ties
- ㉜ Subfloor ventilator
- ㉝ Damp proof course
- ㉞ Base course
- ㉟ Foundations
- ㊱ Solum
- ㊲ Floor joists
- ㊳ Floorboards
- ㊴ Water tank
- ㊵ Hot water tank

Reference may be made in this report to some or all of the above component parts of the property. This diagram may assist you in locating and understanding these items.
