204 Pineridge,
Findhorn,
Forres,
Morayshire,
IV36 3TB

Home Report

Single Survey

Property Address	204 Pineridge, Findhorn, Forres, Morayshire, IV36 3TB
Reference	987170
Customer Name	The Findhorn Foundation
Date of Inspection	24th March 2025
Surveyor's name, qualifications and office	Michael McDonald BLE, MRICS DM Hall LLP Chartered Surveyors 27 High Street Elgin IV30 1EE Tel: 01343 548501 email: elginresidential@dmhall.co.uk
Prepared By	DM Hall LLP

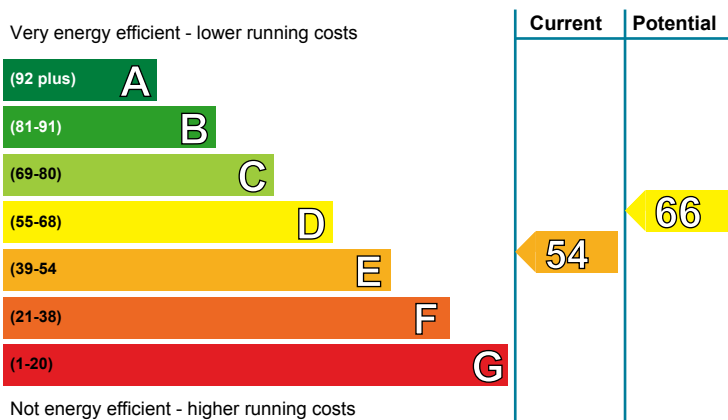
Energy Efficiency Rating

This graph shows the current efficiency of your home, taking into account both energy efficiency and fuel costs. The higher this rating, the lower your fuel bills are likely to be.

Your current rating is **band E (54)**. The average rating for EPCs in Scotland is **band D (61)**.

The potential rating shows the effect of undertaking all of the improvement measures listed within your recommendations report.
