HOME REPORT

KIRKSID COTTAGE DYKE

FORRES
IV36 2TF

Single Survey

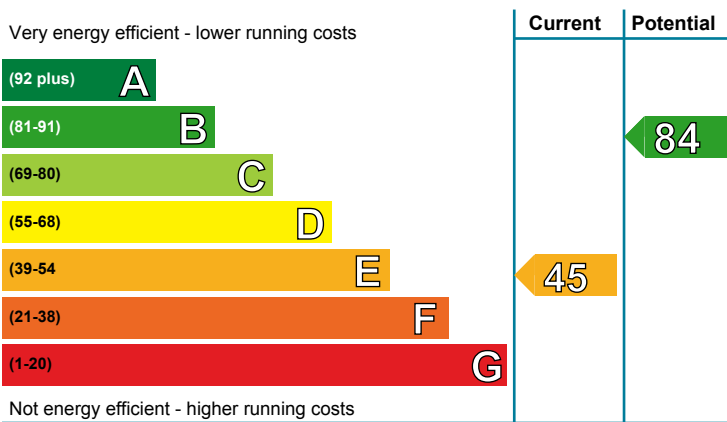
Energy Efficiency Rating

This graph shows the current efficiency of your home, taking into account both energy efficiency and fuel costs. The higher this rating, the lower your fuel bills are likely to be.

Your current rating is **band E (45)**. The average rating for EPCs in Scotland is **band D (61)**.

The potential rating shows the effect of undertaking all of the improvement measures listed within your recommendations report.

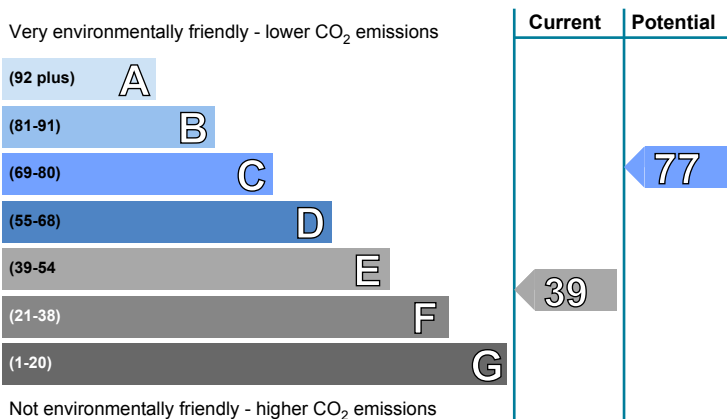
Environmental Impact (CO₂) Rating

This graph shows the effect of your home on the environment in terms of carbon dioxide (CO₂) emissions. The higher the rating, the less impact it has on the environment.

Your current rating is **band E (39)**. The average rating for EPCs in Scotland is **band D (59)**.

The potential rating shows the effect of undertaking all of the improvement measures listed within your recommendations report.
