# HOME REPORT

SHERWOOD COTTAGE  
FINDHORN  
FINDHORN  
IV36 3YE

# ENERGY PERFORMANCE CERTIFICATE

# Single Survey

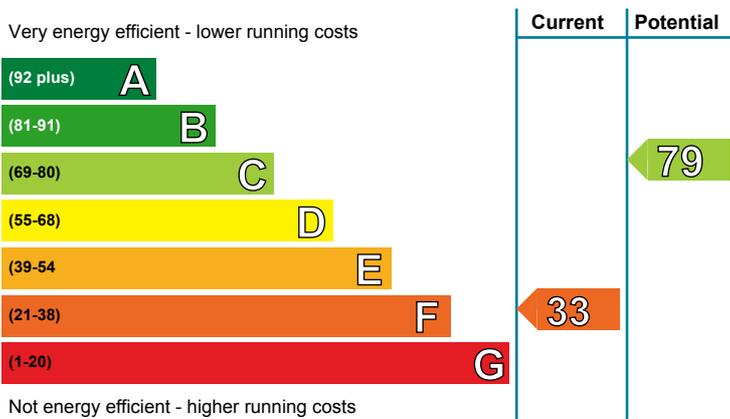
## Energy Efficiency Rating

This graph shows the current efficiency of your home, taking into account both energy efficiency and fuel costs. The higher this rating, the lower your fuel bills are likely to be.

Your current rating is **band F (33)**. The average rating for EPCs in Scotland is **band D (61)**.

The potential rating shows the effect of undertaking all of the improvement measures listed within your recommendations report.

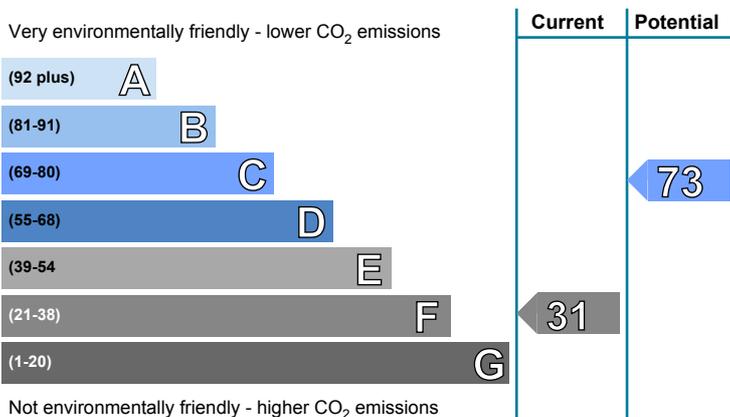
## Environmental Impact (CO<sub>2</sub>) Rating

This graph shows the effect of your home on the environment in terms of carbon dioxide (CO<sub>2</sub>) emissions. The higher the rating, the less impact it has on the environment.

Your current rating is **band F (31)**. The average rating for EPCs in Scotland is **band D (59)**.

The potential rating shows the effect of undertaking all of the improvement measures listed within your recommendations report.
