HOME REPORT

TANNACHY VICTORIA ROAD

FORRES
IV36 3BN

Energy Performance Certificate (EPC)

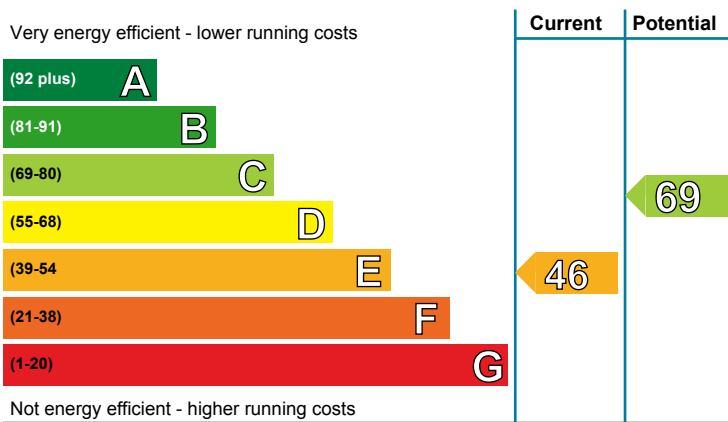
Energy Efficiency Rating

This graph shows the current efficiency of your home, taking into account both energy efficiency and fuel costs. The higher this rating, the lower your fuel bills are likely to be.

Your current rating is **band E (46)**. The average rating for EPCs in Scotland is **band D (61)**.

The potential rating shows the effect of undertaking all of the improvement measures listed within your recommendations report.

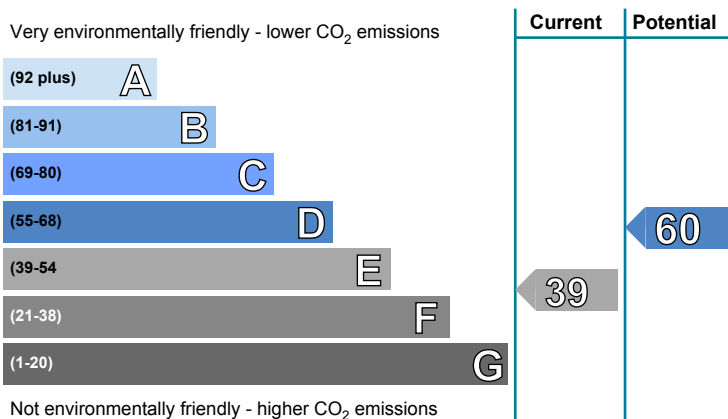
Environmental Impact (CO₂) Rating

This graph shows the effect of your home on the environment in terms of carbon dioxide (CO₂) emissions. The higher the rating, the less impact it has on the environment.

Your current rating is **band E (39)**. The average rating for EPCs in Scotland is **band D (59)**.

The potential rating shows the effect of undertaking all of the improvement measures listed within your recommendations report.
