HOME REPORT

YELLOW SANDS
FINDHORN
FORRES
MORAY
IV36 3YY

Energy Performance Certificate (EPC)

Yellow Sands , Findhorn, Forres, IV36 3YY

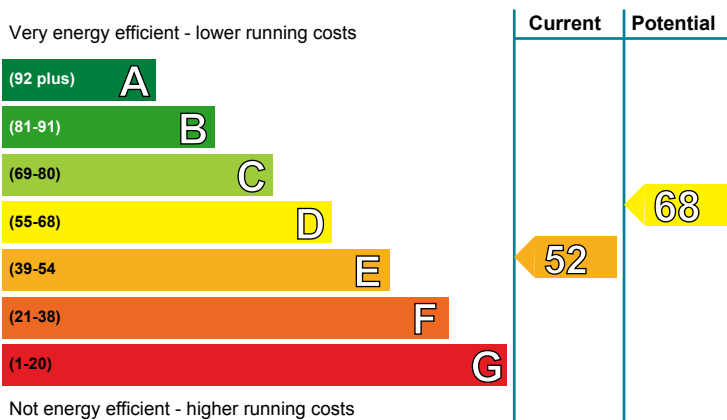
Energy Efficiency Rating

This graph shows the current efficiency of your home, taking into account both energy efficiency and fuel costs. The higher this rating, the lower your fuel bills are likely to be.

Your current rating is **band E (52)**. The average rating for EPCs in Scotland is **band D (61)**.

The potential rating shows the effect of undertaking all of the improvement measures listed within your recommendations report.
