HOME
report

SINGLE SURVEY
ENERGY REPORT
PROPERTY QUESTIONNAIRE
VALUATION REPORT

Single Survey

Property Address	100 High Street, Nairn, IV12 4DE
Customer	Mrs F Tan
Date of Inspection	05/02/2026
Prepared by	Douglas J H Mowat Harvey Donaldson & Gibson Chartered Surveyors

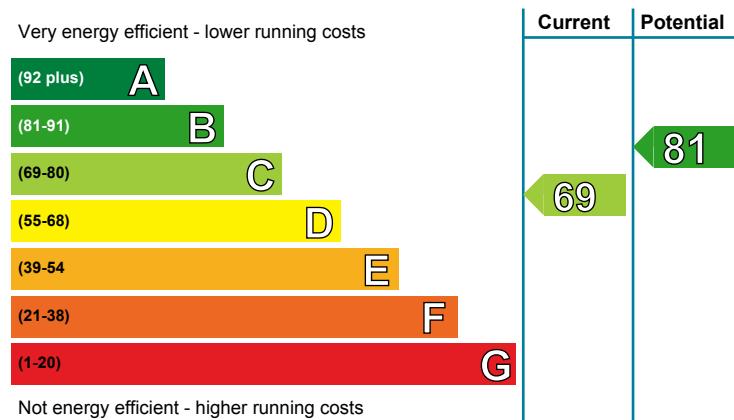
Energy Efficiency Rating

This graph shows the current efficiency of your home, taking into account both energy efficiency and fuel costs. The higher this rating, the lower your fuel bills are likely to be.

Your current rating is **band C (69)**. The average rating for EPCs in Scotland is **band D (61)**.

The potential rating shows the effect of undertaking all of the improvement measures listed within your recommendations report.

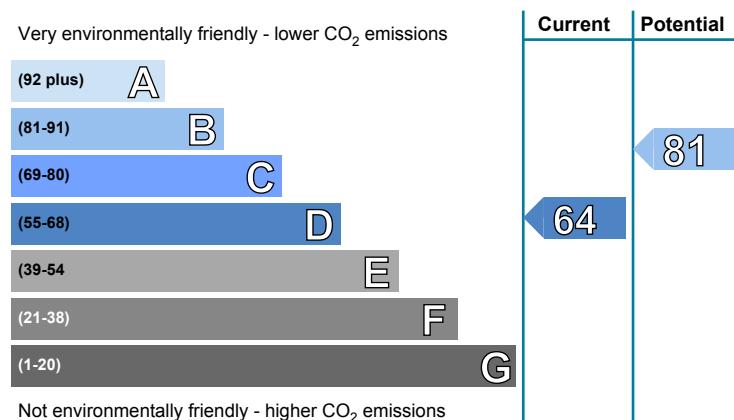
Environmental Impact (CO₂) Rating

This graph shows the effect of your home on the environment in terms of carbon dioxide (CO₂) emissions. The higher the rating, the less impact it has on the environment.
