HOME REPORT

10 DOUGLAS STREET NAIRN IV12 4DJ

SINGLE SURVEY

Property address	10 DOUGLAS STREET NAIRN IV12 4DJ
Customer	Mrs A De Cristofaro (Executor)
Customer address	10 Douglas Street Nairn IV12 4DJ
Prepared by	DM Hall LLP
Date of inspection	15th February 2023

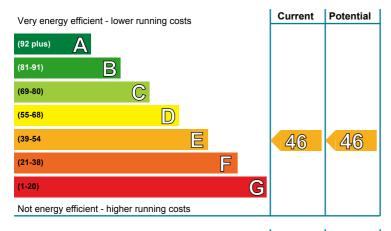
Energy Efficiency Rating

This graph shows the current efficiency of your home, taking into account both energy efficiency and fuel costs. The higher this rating, the lower your fuel bills are likely to be.

Your current rating is **band E (46)**. The average rating for EPCs in Scotland is **band D (61)**.

The potential rating shows the effect of undertaking all of the improvement measures listed within your recommendations report.
