# HOME REPORT

11 ROWAN PLACE  
NAIRN  
IV12 4TL

# Single Survey

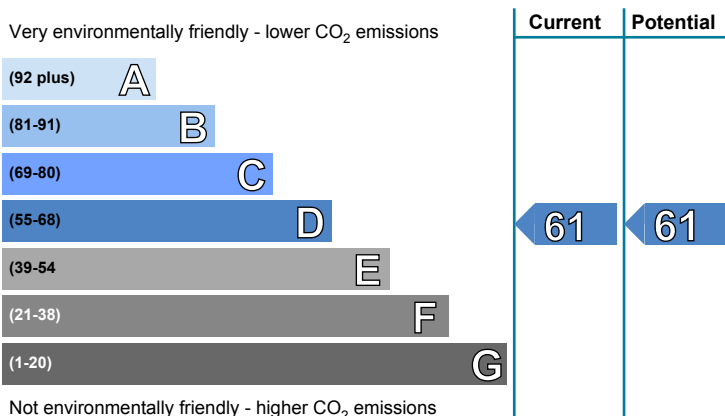
## Environmental Impact (CO<sub>2</sub>) Rating

This graph shows the effect of your home on the environment in terms of carbon dioxide (CO<sub>2</sub>) emissions. The higher the rating, the less impact it has on the environment.

Your current rating is **band D (61)**. The average rating for EPCs in Scotland is **band D (59)**.

The potential rating shows the effect of undertaking all of the improvement measures listed within your recommendations report.
