# Home Report

2 Wyvis Drive,  
Nairn,  
Nairnshire,  
IV12 4SU

# Single Survey

| <b>Date of Inspection</b> | 14th January 2026 |

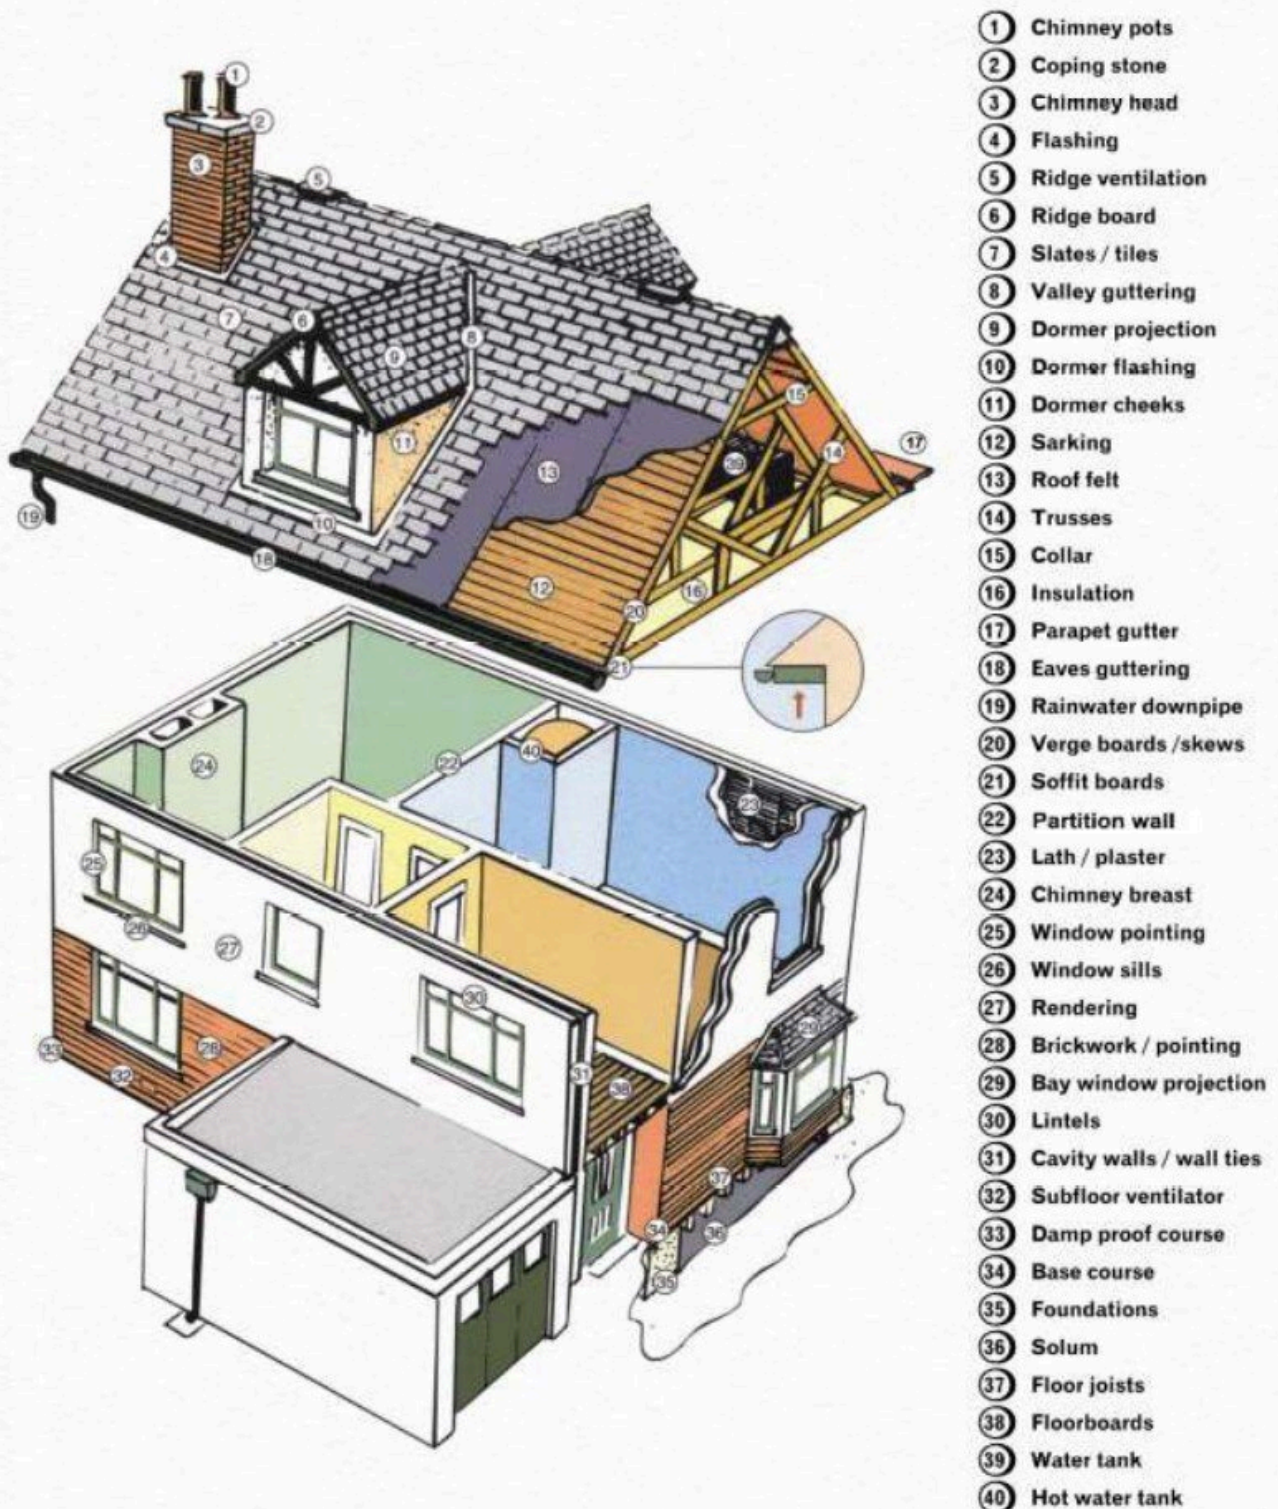
## Sectional Diagram showing elements of a typical house

Reference may be made in this report to some or all of the above component parts of the property. This diagram may assist you in locating and understanding these items.
