HOME REPORT

FLAT 51
HIGH STREET
NAIRN
IV12 4AG

Energy Performance Certificate (EPC)

FLAT 51, HIGH STREET, NAIRN, IV12 4AG

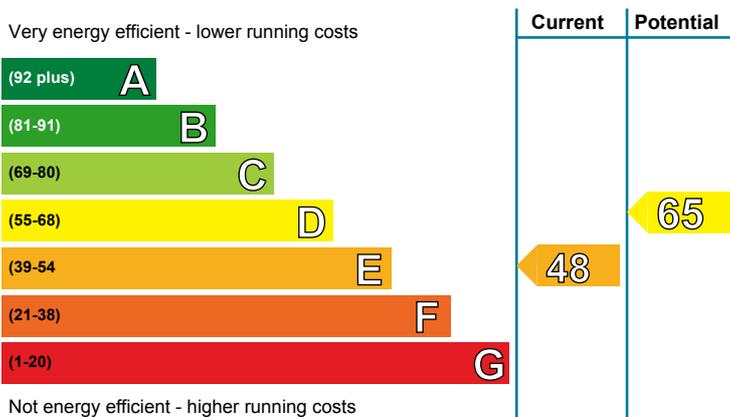
Energy Efficiency Rating

This graph shows the current efficiency of your home, taking into account both energy efficiency and fuel costs. The higher this rating, the lower your fuel bills are likely to be.

Your current rating is **band E (48)**. The average rating for EPCs in Scotland is **band D (61)**.

The potential rating shows the effect of undertaking all of the improvement measures listed within your recommendations report.

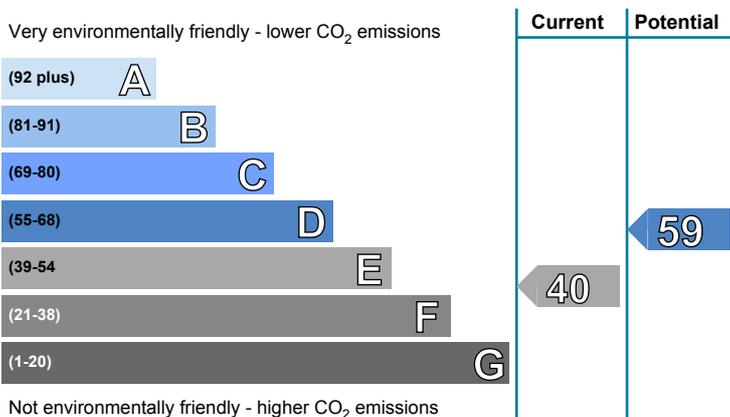
Environmental Impact (CO₂) Rating

This graph shows the effect of your home on the environment in terms of carbon dioxide (CO₂) emissions. The higher the rating, the less impact it has on the environment.

Your current rating is **band E (40)**. The average rating for EPCs in Scotland is **band D (59)**.

The potential rating shows the effect of undertaking all of the improvement measures listed within your recommendations report.

The average Scottish household produces about 6 tonnes of carbon dioxide every year. Based on this assessment, heating and lighting this home currently produces approximately 8.4 tonnes of carbon dioxide every year. Adopting recommendations in this report can reduce emissions and protect the environment. If you were to install all of these recommendations this could reduce emissions by 3.0 tonnes per year. You could reduce emissions even more by switching to renewable energy sources.
