HOME REPORT

77 HARBOUR STREET
NAIRN
IV12 4PY

Energy Performance Certificate (EPC)

Single Survey

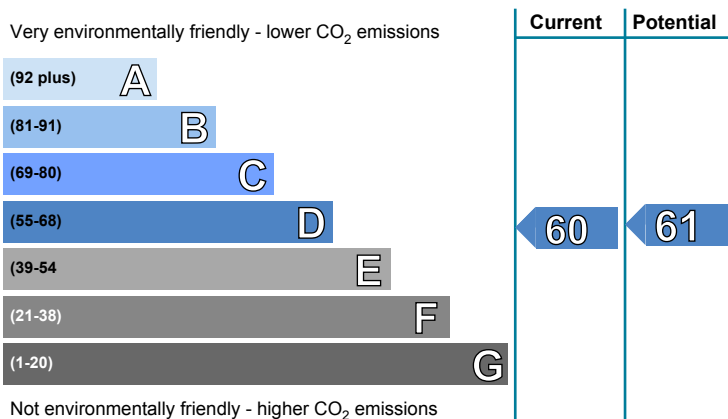
Environmental Impact (CO₂) Rating

This graph shows the effect of your home on the environment in terms of carbon dioxide (CO₂) emissions. The higher the rating, the less impact it has on the environment.

Your current rating is **band D (60)**. The average rating for EPCs in Scotland is **band D (59)**.

The potential rating shows the effect of undertaking all of the improvement measures listed within your recommendations report.
