# HOME REPORT

9 OLD BAR ROAD  
NAIRN  
IV12 5BX

# Energy Performance Certificate (EPC)

9 OLD BAR ROAD, NAIRN, IV12 5BX

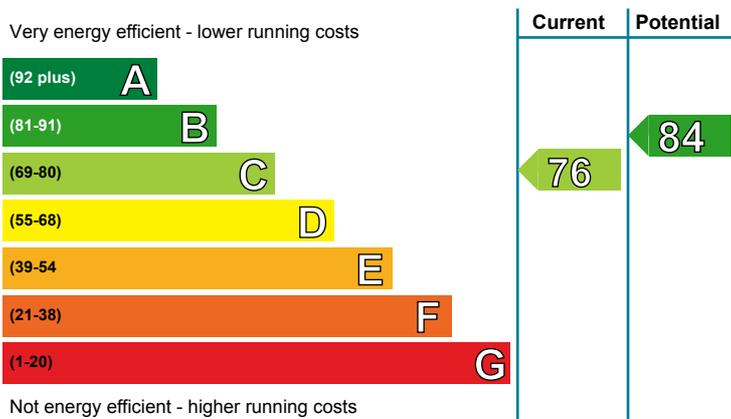
## Energy Efficiency Rating

This graph shows the current efficiency of your home, taking into account both energy efficiency and fuel costs. The higher this rating, the lower your fuel bills are likely to be.

Your current rating is **band C (76)**. The average rating for EPCs in Scotland is **band D (61)**.

The potential rating shows the effect of undertaking all of the improvement measures listed within your recommendations report.
