# HOME REPORT

9 COLIN YOUNG PLACE  
GORDON STREET  
NAIRN  
IV12 4DH

# ENERGY PERFORMANCE CERTIFICATE

# SINGLE SURVEY

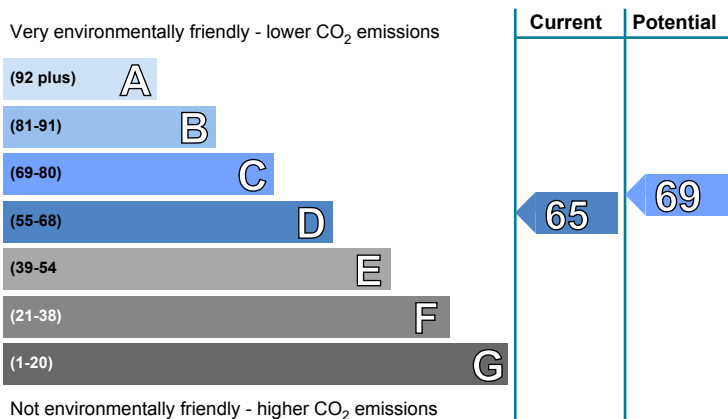
## Environmental Impact (CO<sub>2</sub>) Rating

This graph shows the effect of your home on the environment in terms of carbon dioxide (CO<sub>2</sub>) emissions. The higher the rating, the less impact it has on the environment.

Your current rating is **band D (65)**. The average rating for EPCs in Scotland is **band D (59)**.

The potential rating shows the effect of undertaking all of the improvement measures listed within your recommendations report.
