HOME REPORT

FLAT
2 TARLAND
ALBERT STREET
NAIRN
IV12 4HE

Energy Performance Certificate (EPC)

FLAT 2 TARLAND, ALBERT STREET, NAIRN, IV12 4HE

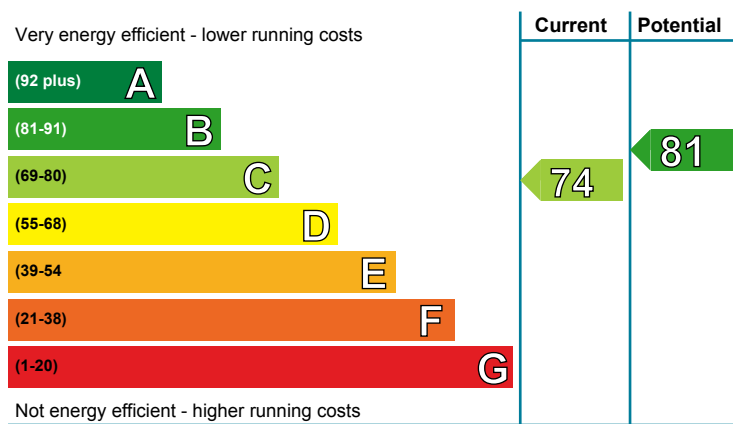
Energy Efficiency Rating

This graph shows the current efficiency of your home, taking into account both energy efficiency and fuel costs. The higher this rating, the lower your fuel bills are likely to be.

Your current rating is **band C (74)**. The average rating for EPCs in Scotland is **band D (61)**.

The potential rating shows the effect of undertaking all of the improvement measures listed within your recommendations report.
