Home Report

Flat 5,
Barron House,
88 High Street,
NAIRN,
IV12 4AU

Single Survey

Survey Report on:

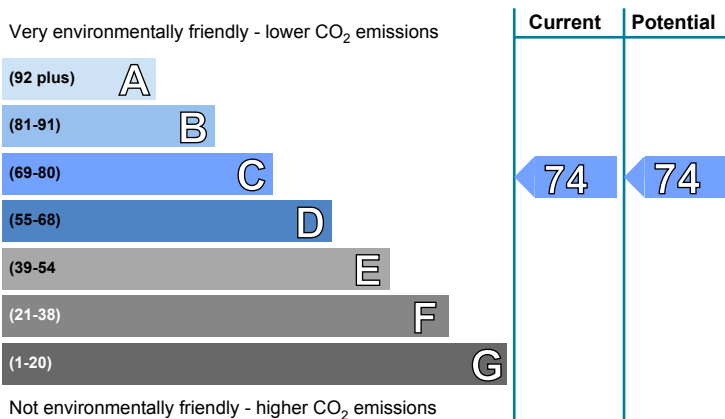
Environmental Impact (CO₂) Rating

This graph shows the effect of your home on the environment in terms of carbon dioxide (CO₂) emissions. The higher the rating, the less impact it has on the environment.
