HOME REPORT

KILNHILL COTTAGE

NAIRN
IV12 5LE

Energy Performance Certificate (EPC)

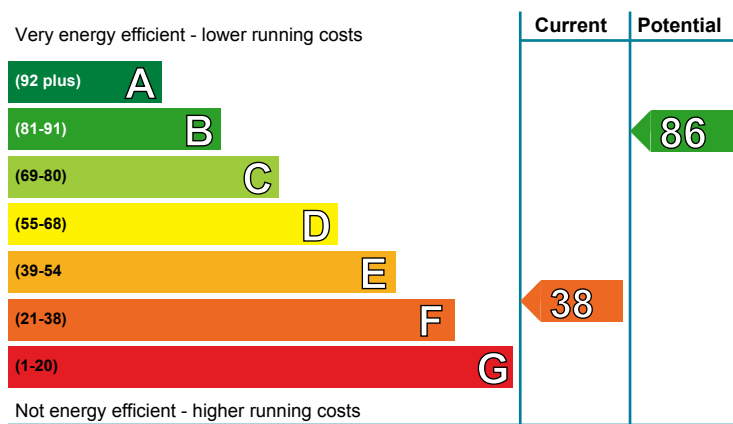
Energy Efficiency Rating

This graph shows the current efficiency of your home, taking into account both energy efficiency and fuel costs. The higher this rating, the lower your fuel bills are likely to be.

Your current rating is **band F (38)**. The average rating for EPCs in Scotland is **band D (61)**.

The potential rating shows the effect of undertaking all of the improvement measures listed within your recommendations report.

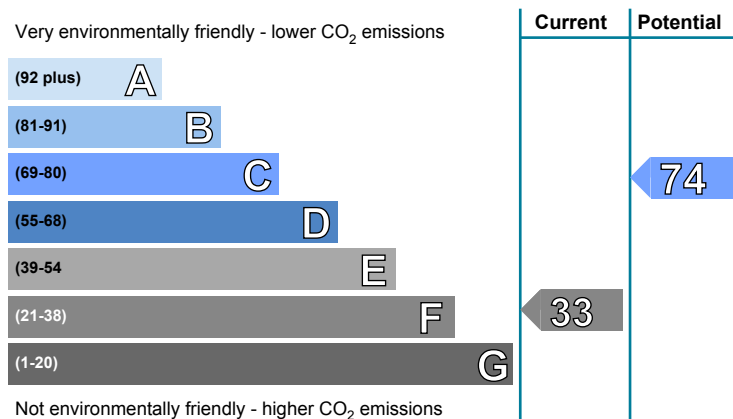
Environmental Impact (CO₂) Rating

This graph shows the effect of your home on the environment in terms of carbon dioxide (CO₂) emissions. The higher the rating, the less impact it has on the environment.

Your current rating is **band F (33)**. The average rating for EPCs in Scotland is **band D (59)**.

The potential rating shows the effect of undertaking all of the improvement measures listed within your recommendations report.
